DEPARTMENT OF TRANSPORTATION

Quality Assurance and Source Inspection

Contract #: 04-0120F4Cty: SF/ALA Rte: 80 PM: 13.2/13.9File #: 69.28**WELDING INSPECTION REPORT****Resident Engineer:**Pursell, Gary**Address:** 333 Burma Road**City:** Oakland, CA 94607**Report No:** WIR-012161**Date Inspected:** 23-Jan-2010**Project Name:** SAS Superstructure**OSM Arrival Time:** 645**Prime Contractor:** American Bridge/Fluor Enterprises, a JV**OSM Departure Time:** 1845**Contractor:** Zhenhua Port Machinery Company, Ltd (ZPMC), Changxing Island **Location:** Shanghai, China**CWI Name:** Li Yang**CWI Present:** Yes No**Inspected CWI report:** Yes No N/A**Rod Oven in Use:** Yes No N/A**Electrode to specification:** Yes No N/A**Weld Procedures Followed:** Yes No N/A**Qualified Welders:** Yes No N/A**Verified Joint Fit-up:** Yes No N/A**Approved Drawings:** Yes No N/A**Approved WPS:** Yes No N/A**Delayed / Cancelled:** Yes No N/A**Bridge No:** 34-0006**Component:** Orthotropic Box Girder (OBG)**Summary of Items Observed:**

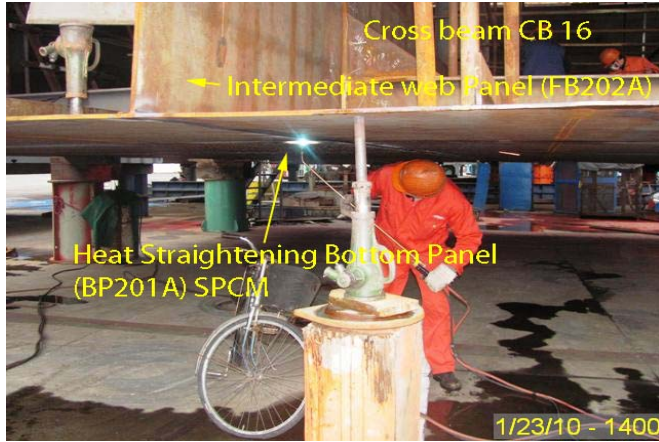
This QA observed ZPMC personnel heat straightening bottom panels identified as BP201A and BP203A on this crossbeam. ZPMC QC identified as Mr. Shen Jian Guo was present to monitor the heat straightening process. Mr. Shen Jian Guo informed this QA that the heat straightening was being performed to correct the weld distortion. The heat straightening process appeared to be in the general compliance with contractor document HSR1 (B)-7995. No other significant work was being performed on this crossbeam during the time QA was present. See attached picture.
